**Flood Control Project Maintenance  
Levee Inspections**

**2011 Channel Summary Report**

**Fairfield Suisun Sewer District**

**Flood Control Project Maintenance****Unit Cover Sheet****2011 Channel Inspection Results****Fairfield Suisun Sewer District**

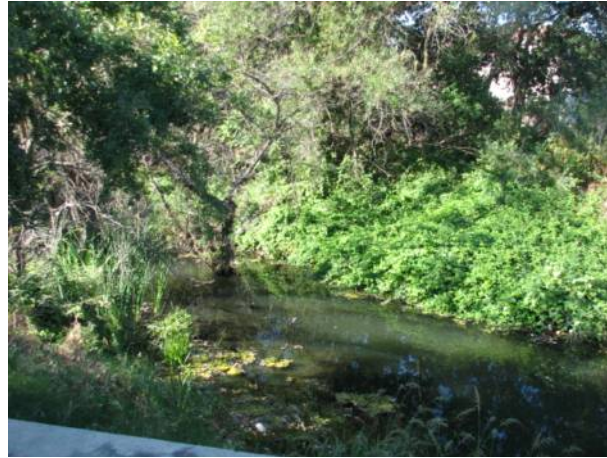
johngw\_c\_20110804\_017.jpg

This is the downstream view of Laurel Creek at Manuel Campos Pkwy. 38.29300 -122.02265

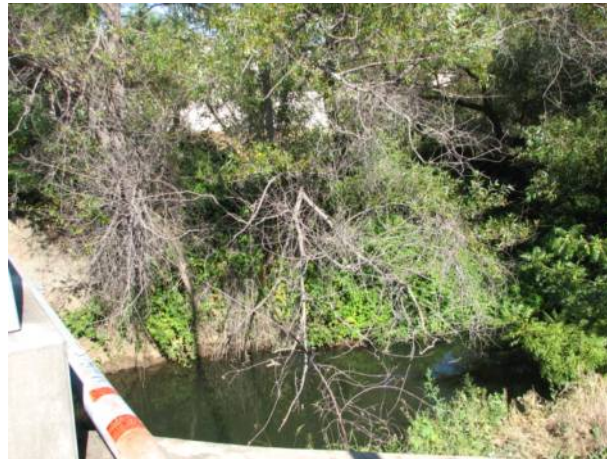
johngw\_c\_20110804\_018.jpg

This is the upstream view of Laurel Creek at Manuel Campos Pkwy.

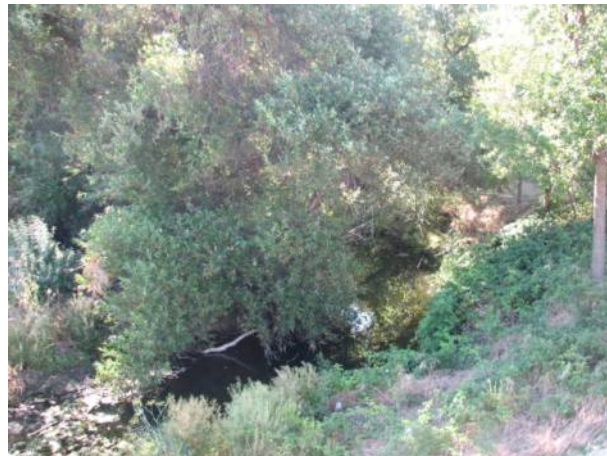
johngw\_c\_20110804\_019.jpg

This view is looking downstream of Laurel Creek at Dickson Hill Rd. The trees need to be raised so not to impede flow. 38.28982 -122.02077

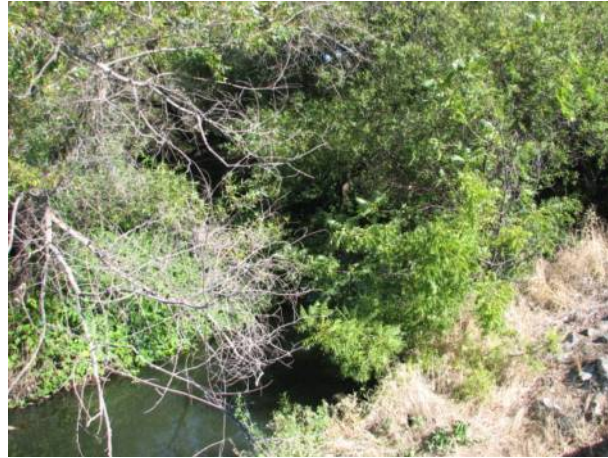
johngw\_c\_20110804\_020.jpg

This is another view of the upstream of Laurel Creek at Manual Campos Pkwy. The trees need to be raised so not to impede flow.

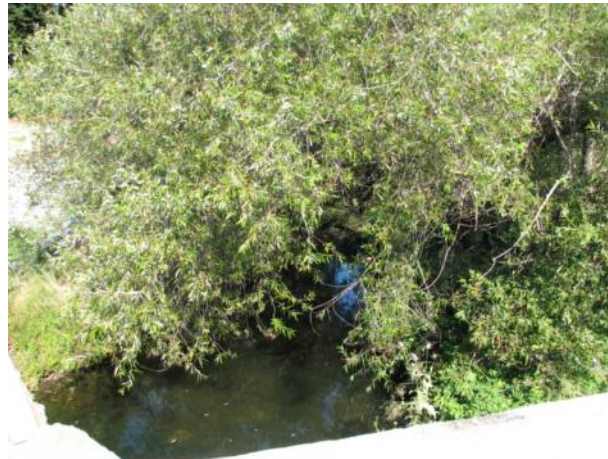
johngw\_c\_20110804\_021.jpg

This view is the upstream view of Laurel Creek at Dickson Hill Rd. The trees need to be raised so not to impede flow.

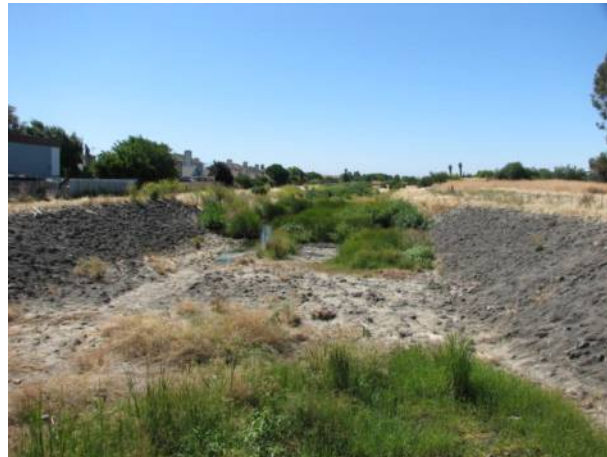
johngw\_c\_20110804\_033.jpg

The photo is looking downstream at Railroad Ave. Trees are growing in the channel. The city of Suisun takes over Laurel Creek.

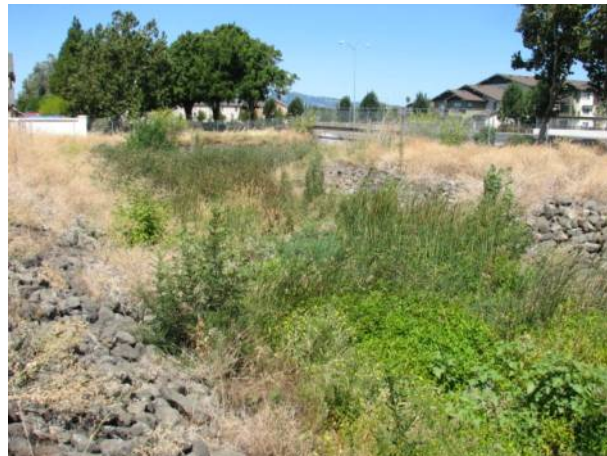
johngw\_c\_20110804\_034.jpg

61	SunsetAve	Up	Vegetation & Obstructions		U	Inspector Comments: Vegetation growth (such as cat tails, bull rushes, bushes or saplings) or other obstructions block approximately 50% of the FCW.	38.253409 ° -122.020114 °	Y	61
62		Up	Shoaling / Sedimentation		A	Inspector Comments: No shoaling or sedimentation present.	38.253409 ° -122.020114 °		62
63		Up	Erosion / Bank Caving		A		38.253409 ° -122.020114 °		63
64		Up	Revetments		M	Inspector Comments: No riprap displacement or scouring activity. Unwanted vegetation must be cleared and sprayed with an appropriate herbicide.	38.253409 ° -122.020114 °		64
65		Up	Encroachments		A	Inspector Comments: No Trash, debris, excavation, structures, or other obstructions present within the project easement area.	38.253409 ° -122.020114 °		65
66		Down	Vegetation & Obstructions		U	Inspector Comments: Vegetation growth (such as cat tails, bull rushes, bushes or saplings) or other obstructions block approximately 50% of the FCW.	38.253409 ° -122.020114 °	Y	66

The photo is looking upstream at Sunset Ave and Railroad Ave. Trees and brush need to be sprayed or cut out.

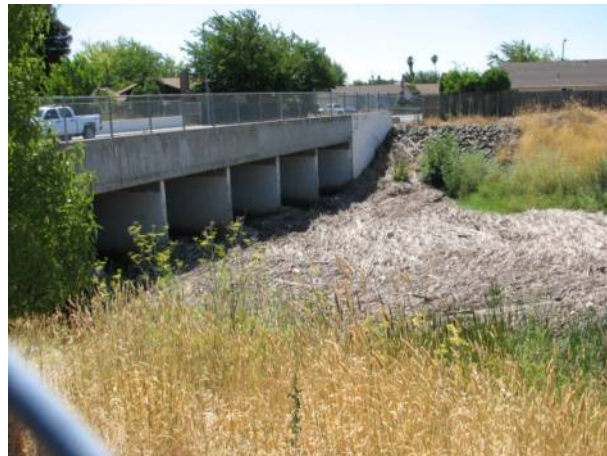
johngw\_c\_20110804\_037.jpg

The debris is dead cattails that has collected at the bridge and creates some blockage.

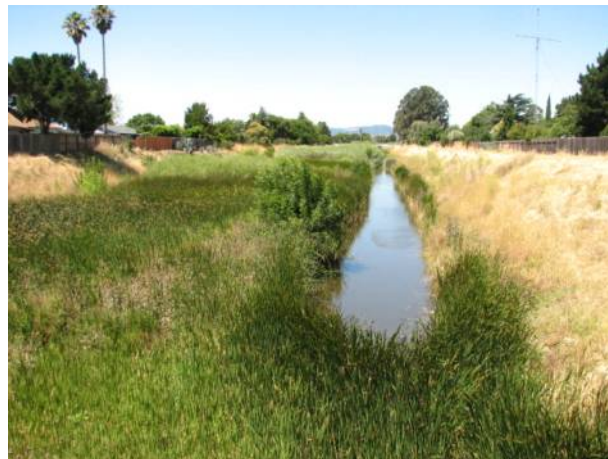
johngw\_c\_20110804\_039.jpg

The photo is looking upstream at Worley Rd. Cattails are encroaching into the bridge and could create blockage.

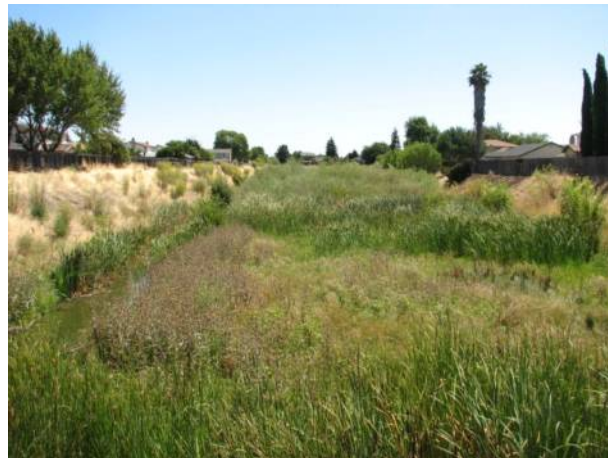
johngw\_c\_20110804\_040.jpg

The photo is looking downstream at Worley Rd. Willows and other trees are growing in the channel.

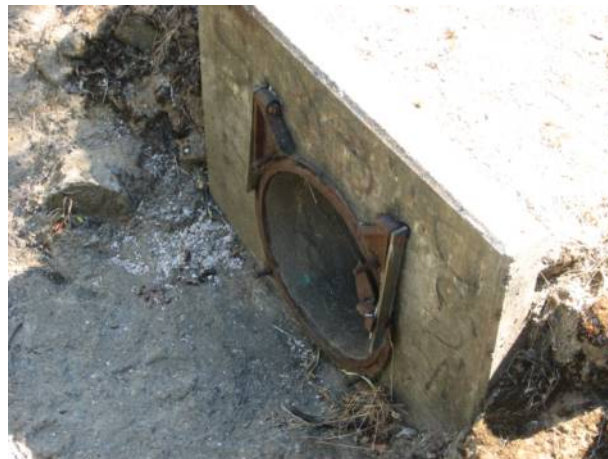
johngw\_c\_20110804\_056.jpg

The flap gate is broken off and needs to be replaced.

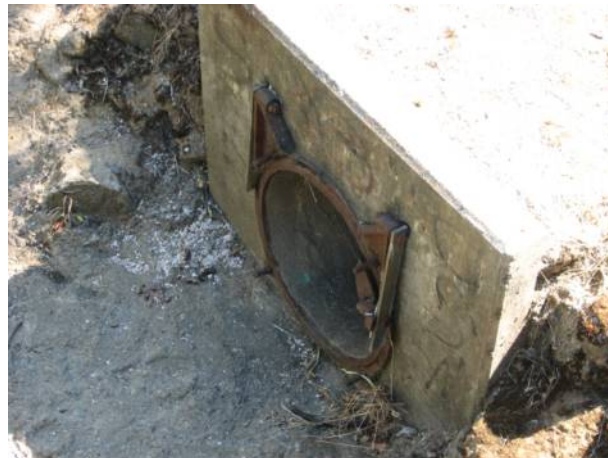
johngw\_c\_20110810\_071.jpg

The flap gate on the up stream side is missing and needs to be replaced.

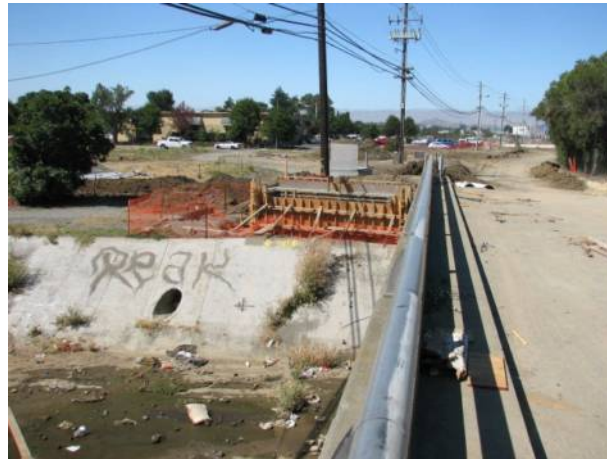
johngw\_c\_20110804\_061.jpg

The photo is the footing on the right bank.

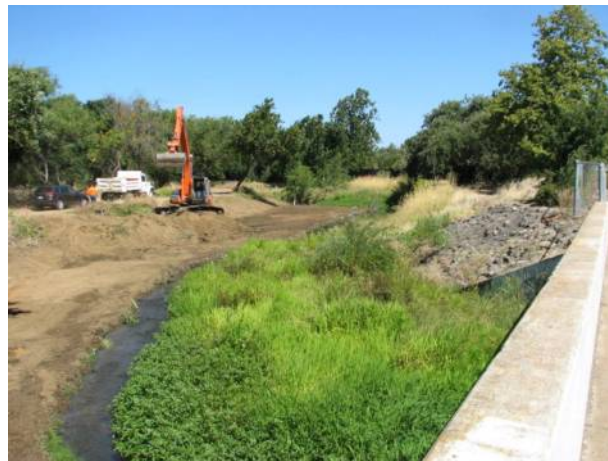
johngw\_c\_20110804\_064.jpg

The photo is looking upstream at Beck Ave. The work is for permit 18591.

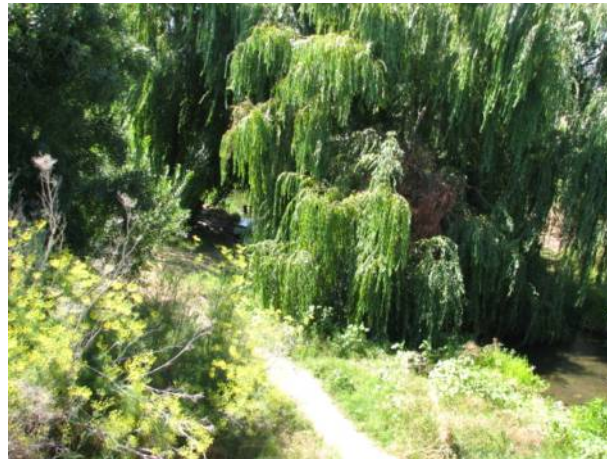
johngw\_c\_20110804\_067.jpg

The photo is looking downstream at Highway 12.  
The trees need to be raised.

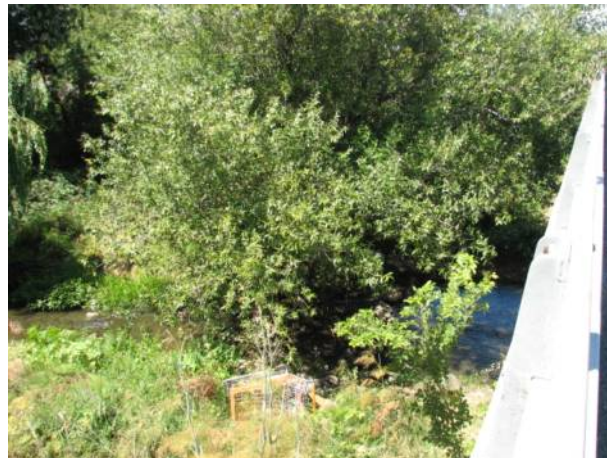
johngw\_c\_20110804\_068.jpg

The trees need to be trimmed up to 5 ft.

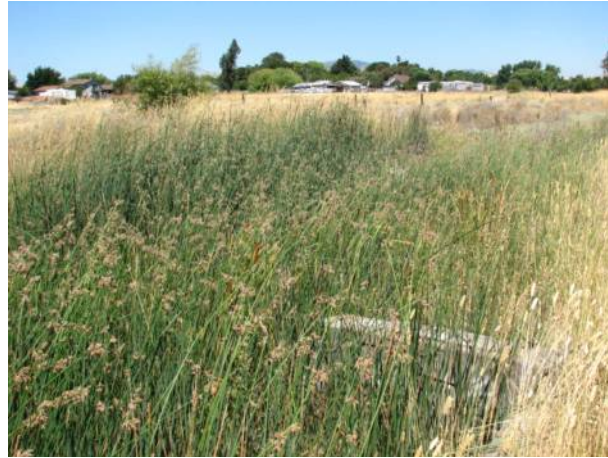
Levee Mile Report Line	1
Start Levee Mile	0.00
End Levee Mile	0.00
Location	
Category	Channels
Item	Vegetation & Obstructions
<p>The photo is looking upstream at Bella Vista Dr. The flashboard structure is completely obstructed by cattails and could not function.</p> <p>johngw_c_20110804_041.jpg</p>
